#### BURSLEDON, HAMBLE-LE-RICE & HOUND LOCAL AREA COMMITTEE

#### HAMBLE LANE SPEED LIMIT REVIEW

# Report of the Head of Engineering

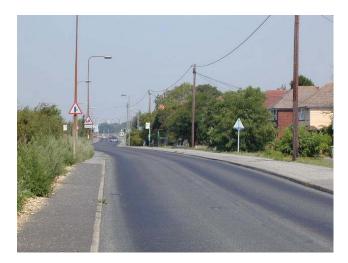
Figure 1: Hamble Lane (facing north)

- 14. The introduction of physical features to slow traffic such as build-outs or pinch-points would not be acceptable on Hamble Lane, owing to the nature of the road and the type of vehicles using it. Additional lining and coloured surfacing alone is likely to achieve a small reduction of speed, however it is recommended that consideration be given to the use of alternative measures in addition, such as speed limit roundels at the entry points to the limit and Vehicle Activated Signs.

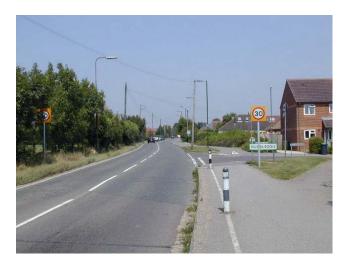
Figure 2: Hamble Lane/Mallards Road junction (facing north)

- 23. The stretch of 30mph speed limit on Hamble Lane further north and the limit on the adjoining section of Portsmouth Road has been raised as an area of concern, in that many motorists are unaware that the limit has changed (Appendix 2).
- 24. It is apparent that speeds have increased since the introduction of the lowered limit. No reason for this can be given, other than the fact that motorists may not be aware that the limit is 30mph or believe that a higher speed is more appropriate for the character of the road and therefore choose to ignore it.

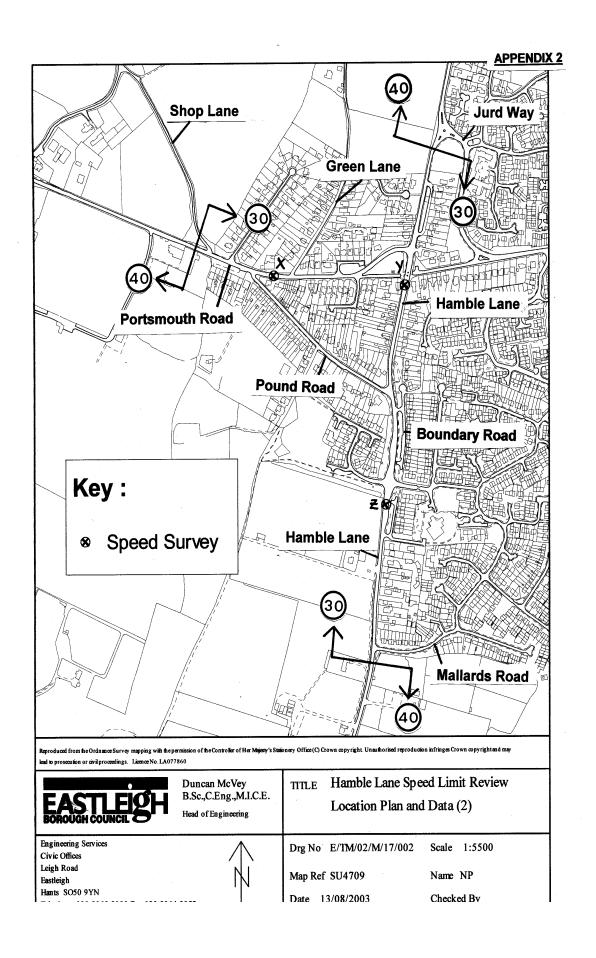
### STICK DIAGRAM

Location: Hamble Lane
Personal Injury Accidents for 3 years from 01/01/00 to 31/12/02
